22 UNITED STATES OF AMERICA,
23
24 Plaintiff,
25
26 v.
27
28 PACIFIC GAS AND ELECTRIC
COMPANY,
Defendant.

No. C 14-00175-WHA

**VICTIMS' RESPONSE TO SECOND
ORDER TO SHOW CAUSE WHY
PG&E'S CONDITIONS OF
PROBATION SHOULD NOT BE
MODIFIED (DOC. # 1027)**

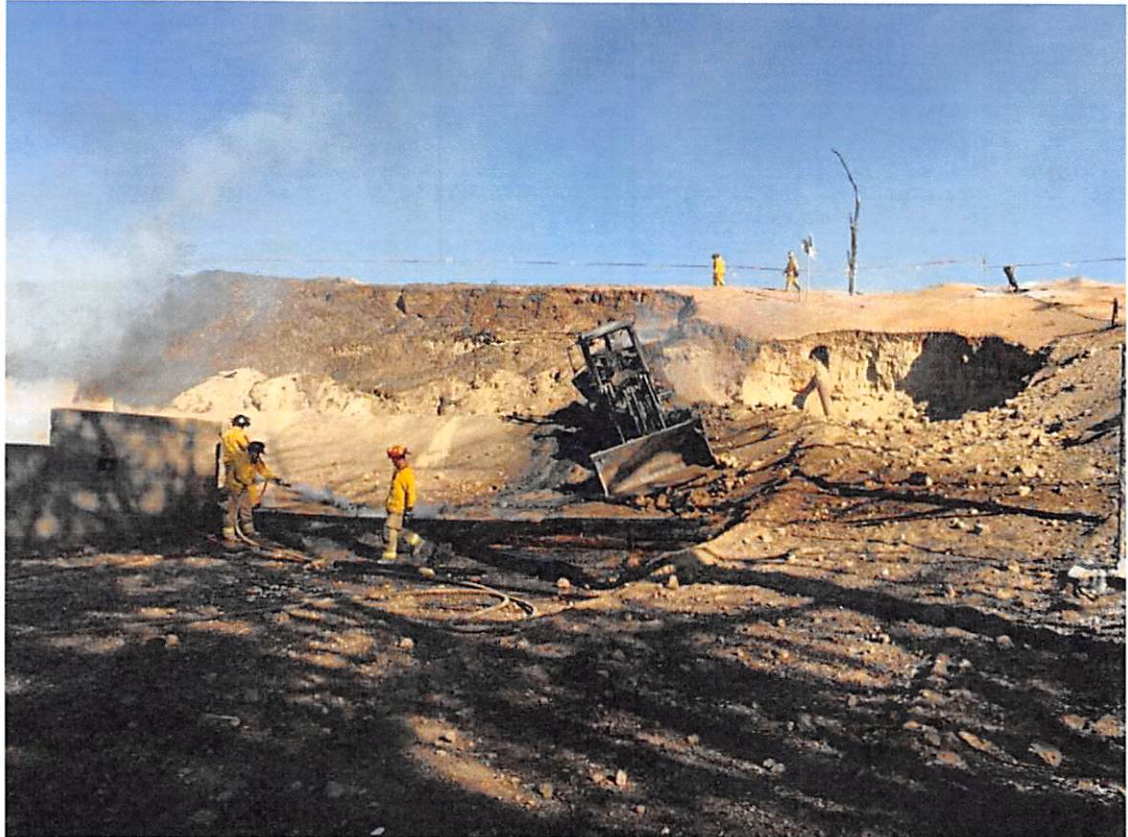
1 Line 118B exploded when the blade of the front loader struck the pipe that was buried mere
2 inches below the surface of the road. The initial explosion propelled dirt and debris at the front loader,
3 shattering its windshield, and propelling it off the ground to where it landed several feet away as shown
4 in the following photograph.

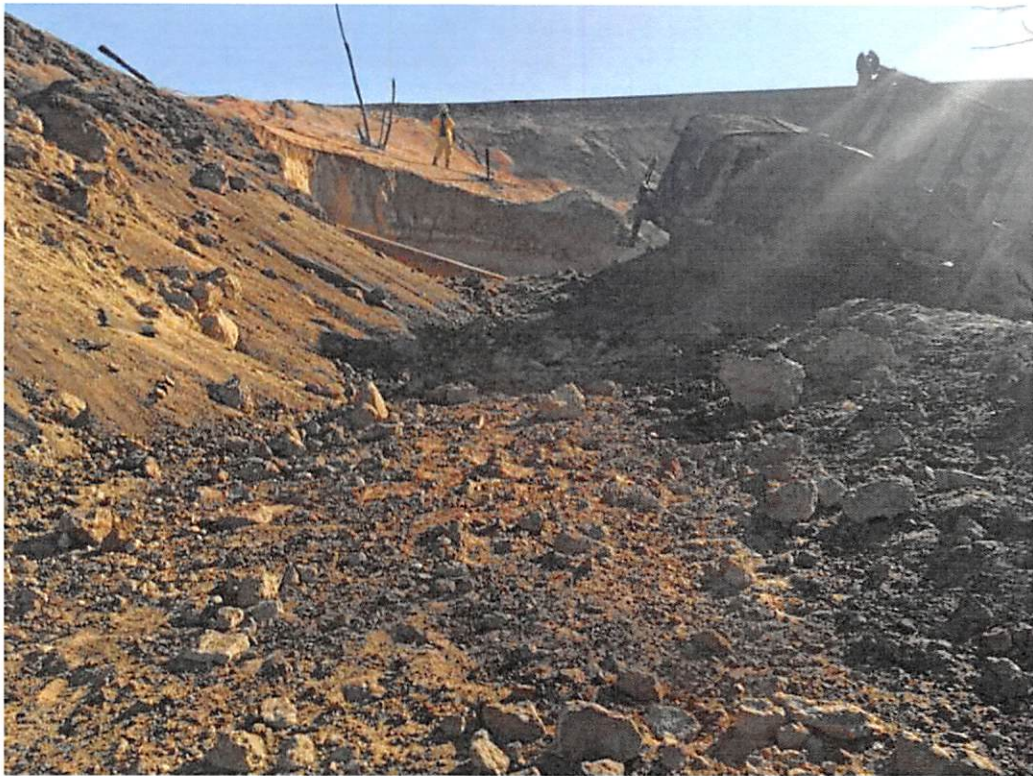
1 At the time of the explosion, Line 118B was pressurized at a minimum level of 370 pounds
2 per square inch ("psi.") It took PG&E almost one hour to shut off the flow of gas that was feeding the
3 flames, inhibiting with first responders' ability to control and extinguish the fire. Even though 49
4 C.F.R. § 192.327 required a minimum of 30-36 inches of cover over Line 118B, it had virtually no
5 cover where it passed under the south side of the bench road at the point where it exploded under
6 Plaintiff's work vehicle. Under the supervision of the CPUC, PG&E's retained engineering expert
7 examined the site and the pipe and determined that Line 118B had "minimal depth of cover" at the
8 point of failure. The following photograph looking westward along the bench road gives a good
9 perspective on how shallow the cover over the pipeline was as it passed under the bench road.

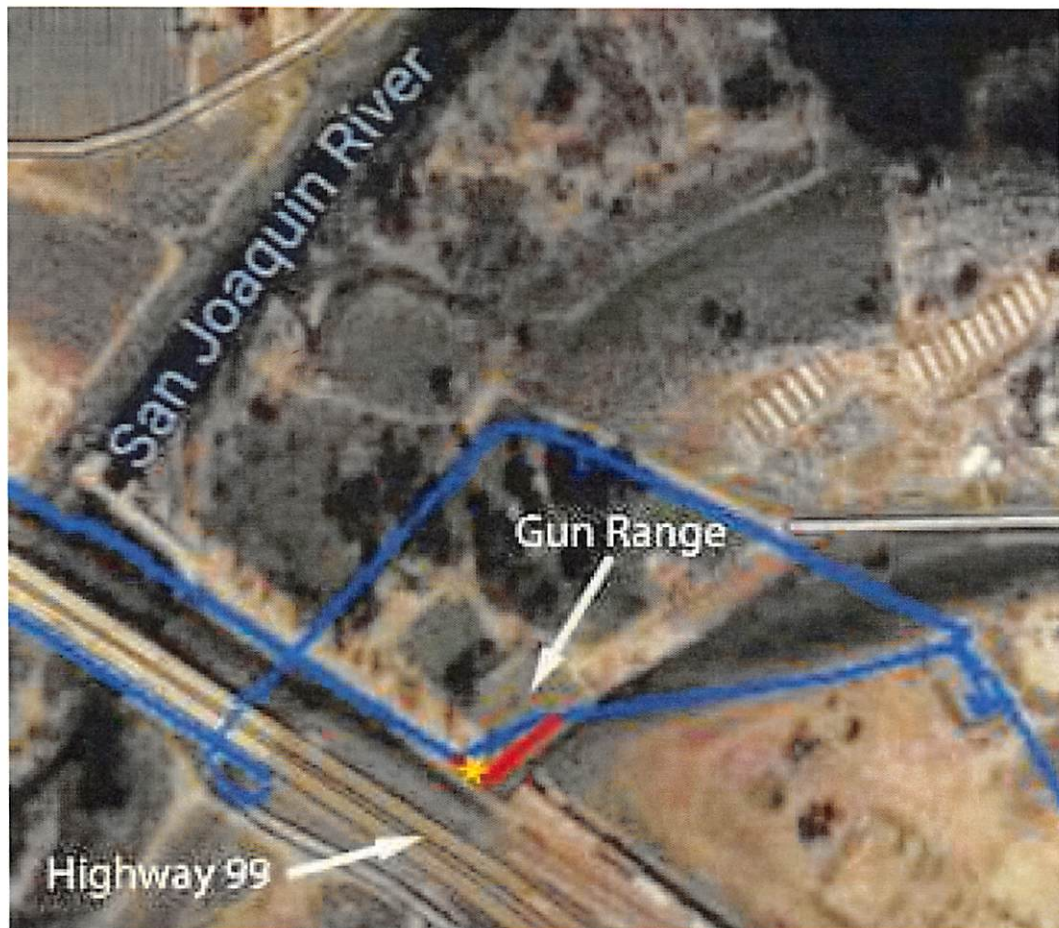
5 The map of Line 118B appearing on PG&E's website still – even four years later – does not
6 accurately depict the location of the Pipeline, incorrectly showing it running only part way across the
7 bluff, then down the bluff, and then angling through the center of the gun range approximately 200
8 feet to the east of its actual location. The following map is an enlargement from PG&E's 2019 website
9 showing PG&E's mapping of Line 118B in blue, the line's actual location in red, and the explosion
10 site as a yellow star:

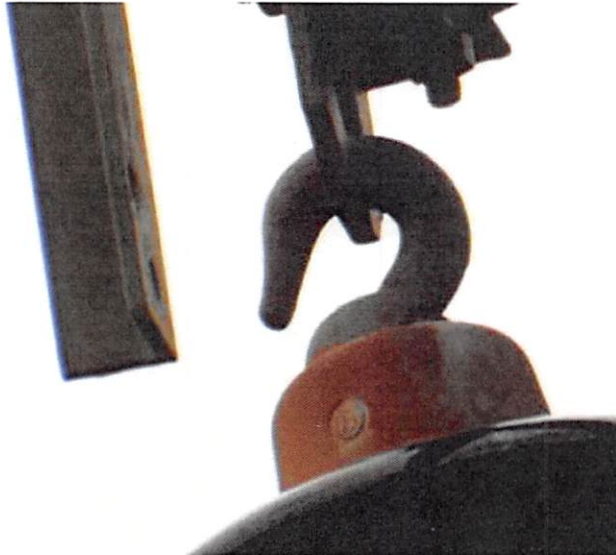
27 “J-hooks” (or “C-hooks” as they are called by some) are hangers from which insulator strings
 28 or other components are hung from transmission towers. The following photograph shows a J-hook

1 supporting an insulator string on the tower immediately adjacent to Tower :27/222 (the “Adjoining
2 Tower”) that is similar to the one that failed and led to the ignition of the Camp Fire.
